| | EMERGENCY MAINTENANCE OF ELEVATED WATER TANK CAUSED BY 7.8 MAGNITUDE EARTHQUAKE ON JUNE 8, 2026 | <br>JOSE CARLITO Y. BRIONES JR.<br>DRAFTSMAN II (COS) | <br>RYAN L. BADAJOS<br>SENIOR ENGINEER A | <br>MARIA VIVIEN M. TANCO<br>PRINCIPAL ENGINEER A | <br>EDEL PETER L. DE LA ROSA<br>ACTING ESD MANAGER | <br>ATTY. CESAR M. DATAYA<br>PORT MANAGER | 1. LOCATION PLAN | 1/5 |
| | PORT OF GENERAL SANTOS, MAKAR WHARF,<br>GENERAL SANTOS CITY | | | | | | | |

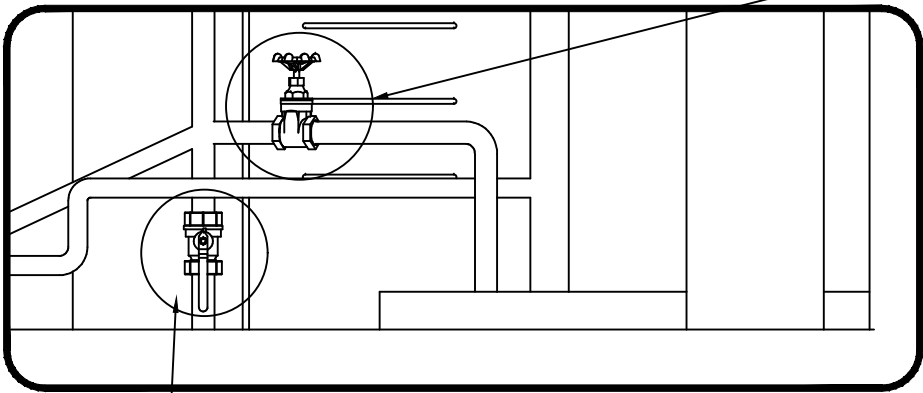
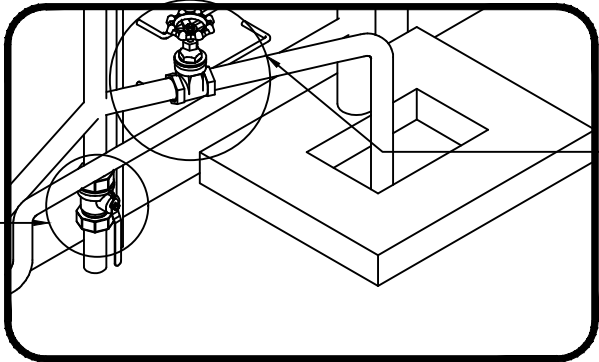
DETAIL A FRONT ELEVATION  
1:30

EXISTING THREADED 3"Ø GATE VALVE TO BE REPLACED WITH 3"Ø GATE VALVES FLANGE TYPE WITH RUBBER SEAL (CAST IRON)

FLANGE PROVIDED BY THE CONTRACTOR

1. PROVIDE FLANGES TO MATCH EXISTING DIMENSIONS (THICKNESS, NUMBER OF BOLT AND HOLE DIMENSION) COMPATIBLE WITH THE SUPPLIED FLANGED GATE VALVE. ALSO PROVIDE AND INSTALL NEW FULL-FACE RUBBER GASKET AND BOLTS/NUTS.
2. PERFORM LEAK TEST.
