| | EMERGENCY MAINTENANCE OF PTB AT TS1, CAUSED BY A 7.8 MAGNITUDE EARTHQUAKE ON JUNE 8, 2026<br>LOCATION<br>PORT OF GENERAL SANTOS, MAKAR WHARF, GENERAL SANTOS CITY | JOSE CARLITO Y. BRIONES JR.<br>DRAFTSMAN II (COS) | RYAN L. BADAJOS<br>SENIOR ENGINEER A | MARIA VIVIEN M. TANCO<br>PRINCIPAL ENGINEER A | EDELPETER L. DE LA ROSA<br>ACTING ESD MANAGER | ATTY. LUZ PATRICIA F. TANCO<br>PSD MANAGER | ATTY. CESAR M. DATAYA<br>PORT MANAGER | 1. TRANSIT SHED LAYOUT | 2/7 |

PROJECT TITLE  
EMERGENCY MAINTENANCE OF PTB AT TS1, CAUSED BY A 7.8  
MAGNITUDE EARTHQUAKE ON JUNE 8, 2026  
LOCATION  
PORT OF GENERAL SANTOS, MAKAR WHARF,  
GENERAL SANTOS CITY

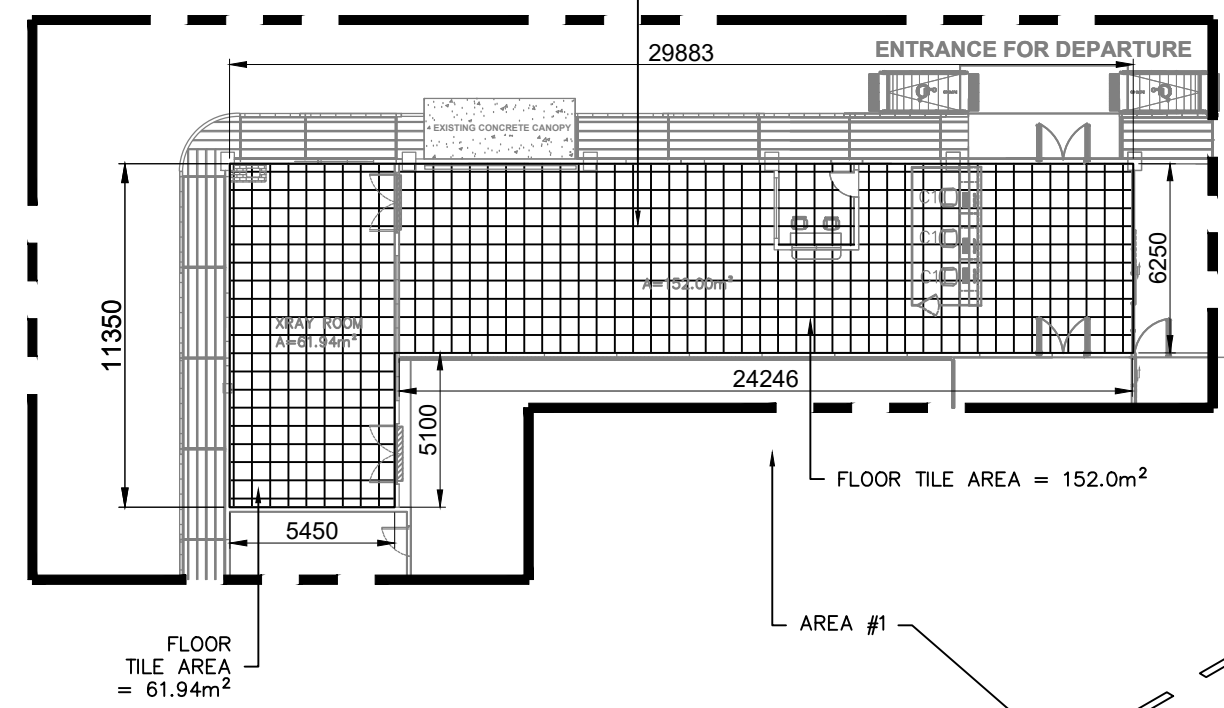
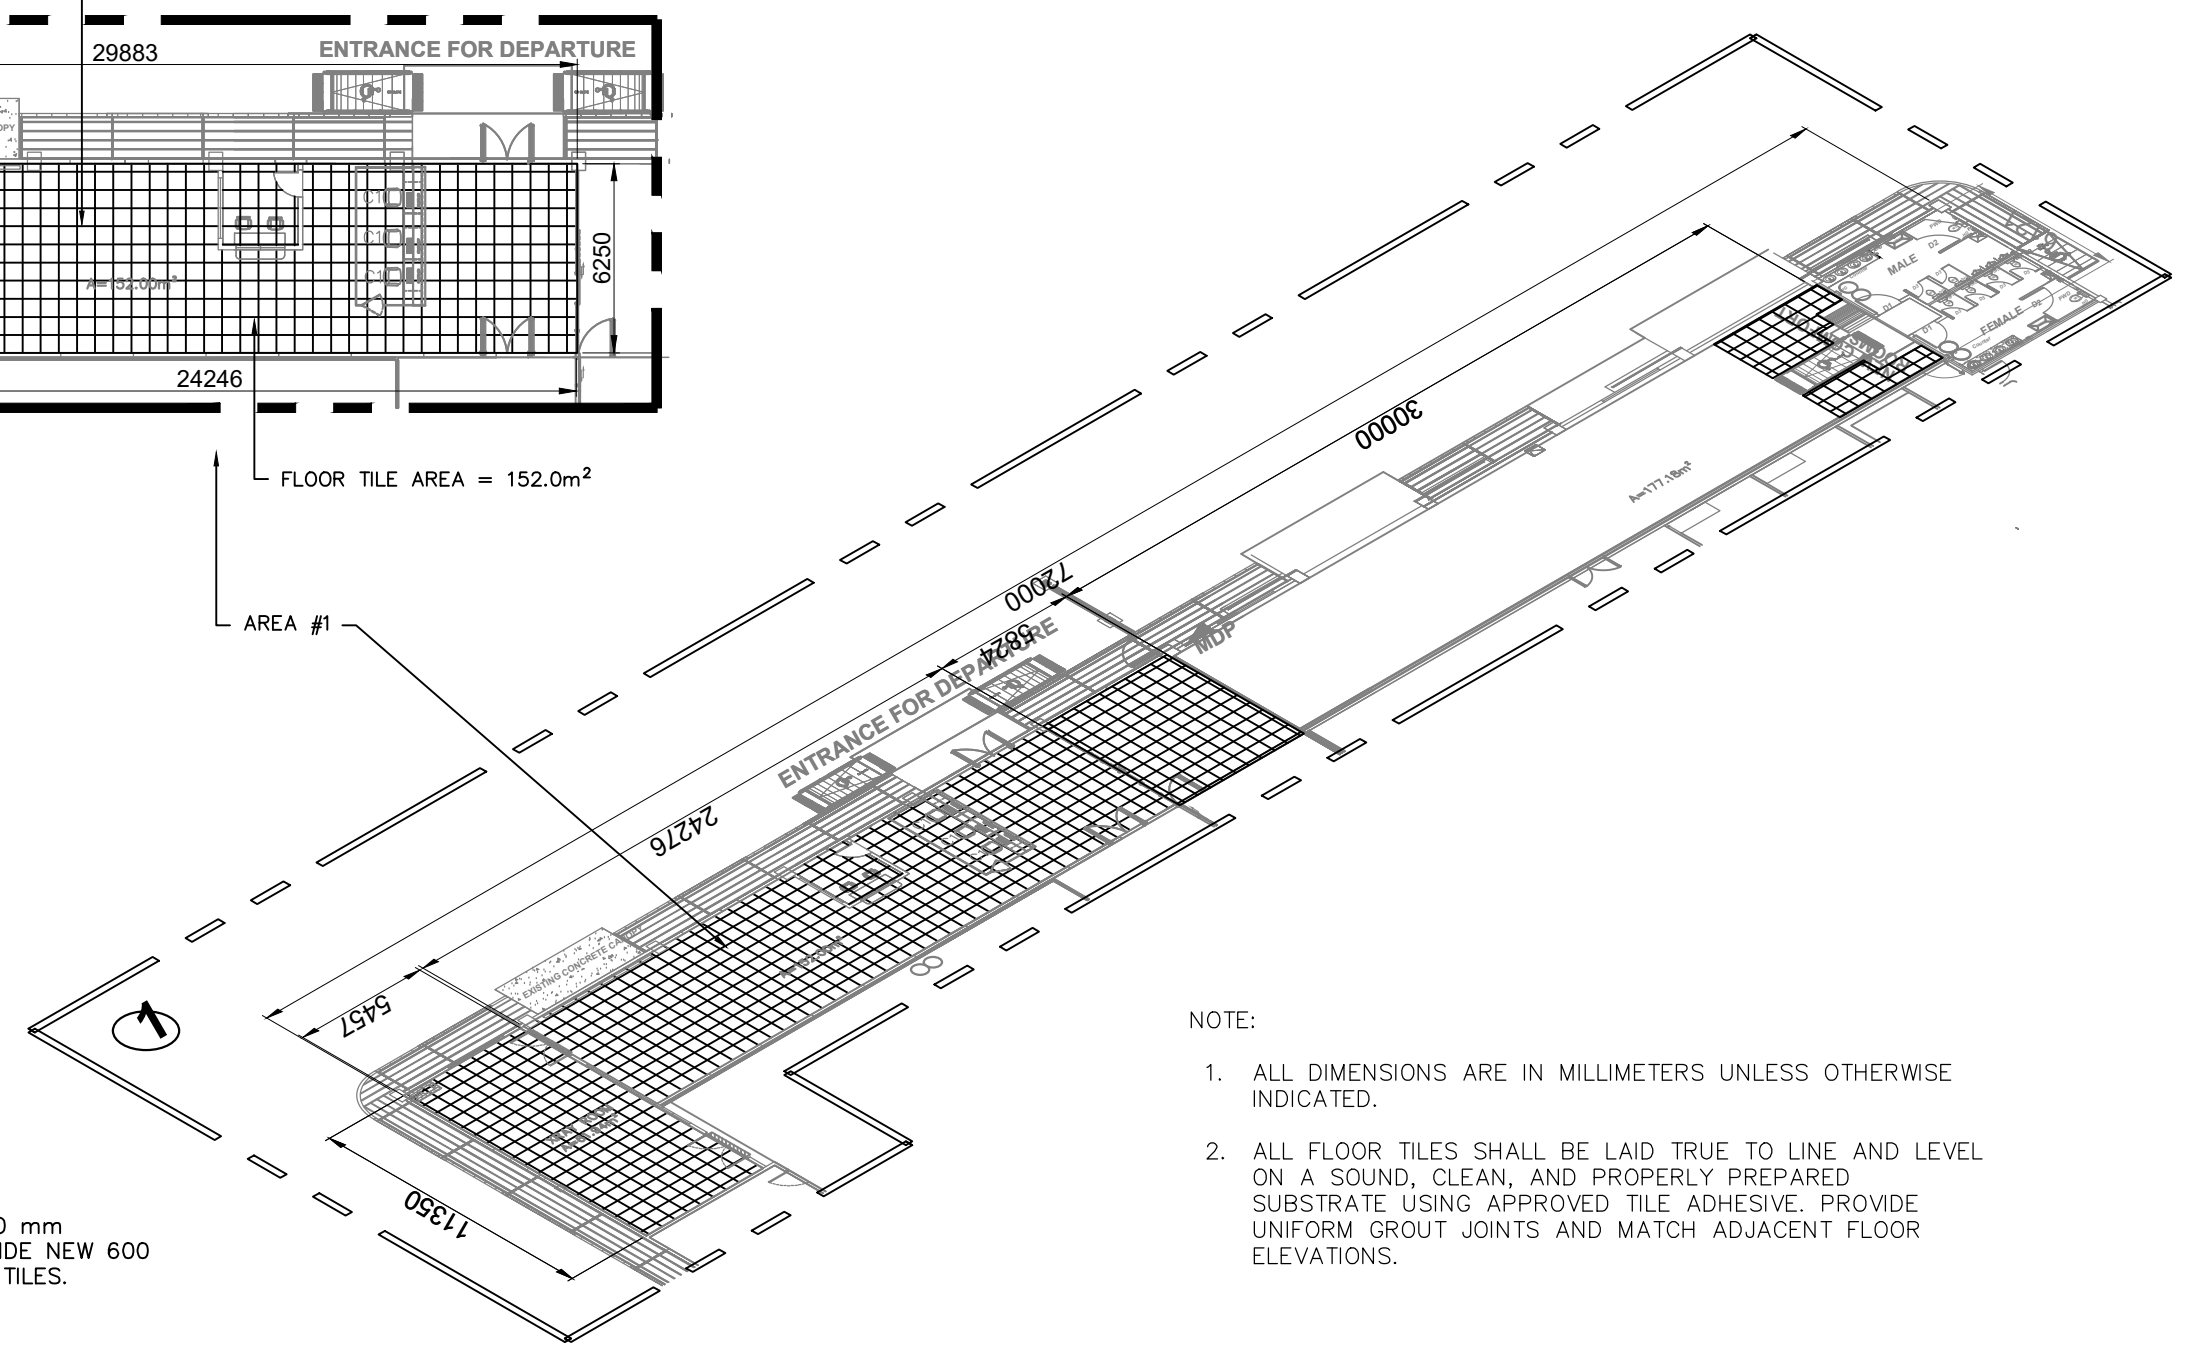
**FLOOR TILE LAYOUT**  
SCALE 1:250

REMOVED EXISTING 600mm x 600mm GRANITE TILES AND PROVIDE 600mm x 600mm CERAMIC TILES

REMOVE EXISTING 600 mm x 600 mm GRANITE FLOOR TILES AND PROVIDE NEW 600 mm x 600 mm CERAMIC FLOOR TILES.

1. ALL DIMENSIONS ARE IN MILLIMETERS UNLESS OTHERWISE INDICATED.
2. ALL FLOOR TILES SHALL BE LAID TRUE TO LINE AND LEVEL ON A SOUND, CLEAN, AND PROPERLY PREPARED SUBSTRATE USING APPROVED TILE ADHESIVE. PROVIDE UNIFORM GROUT JOINTS AND MATCH ADJACENT FLOOR ELEVATIONS.

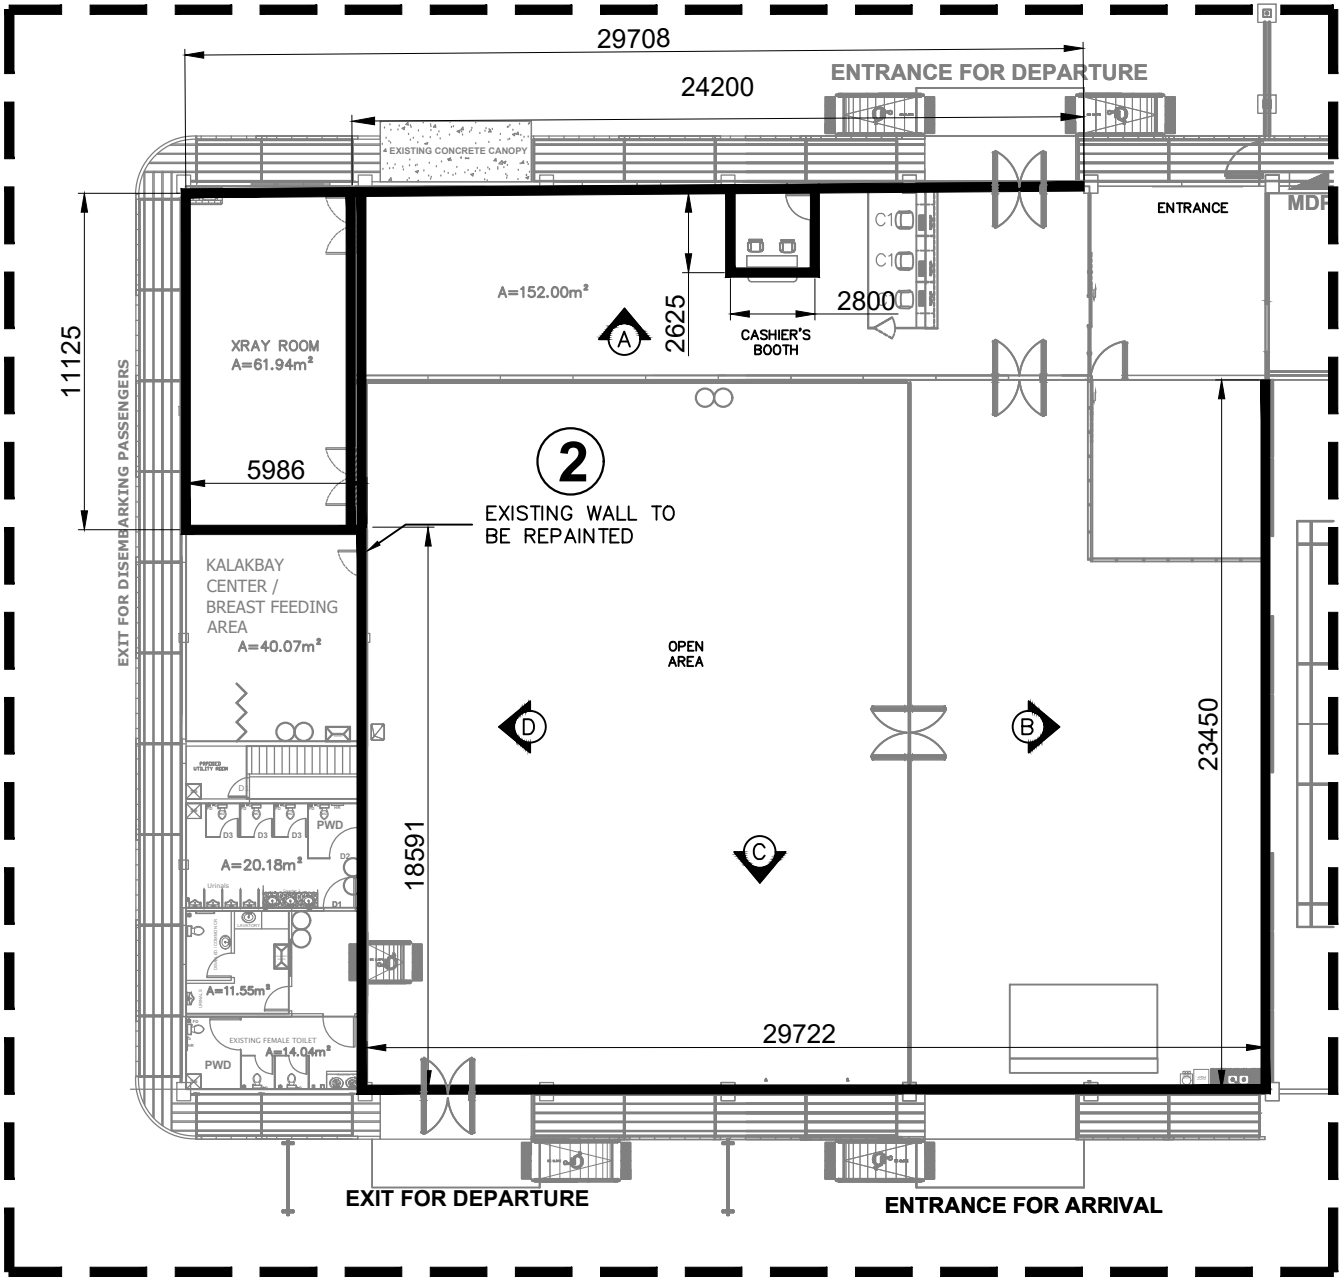
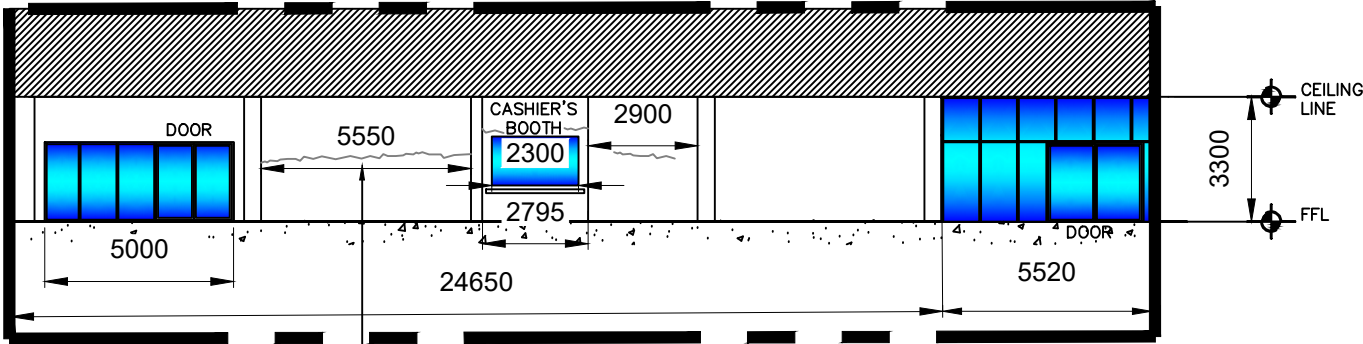
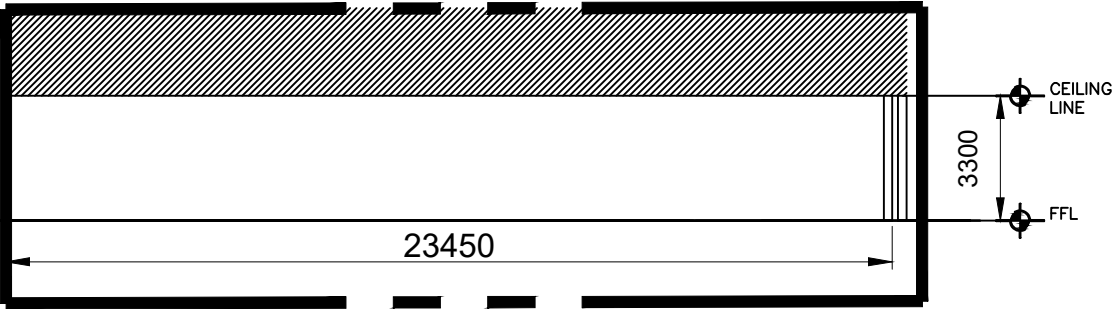
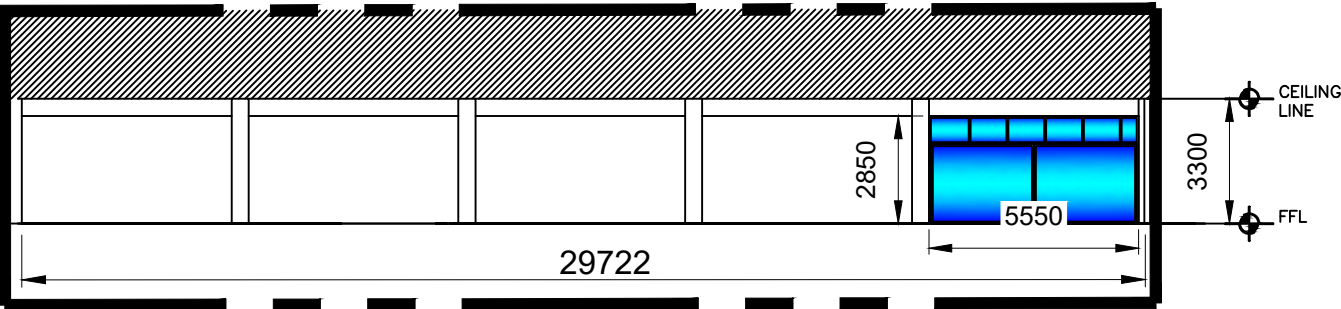
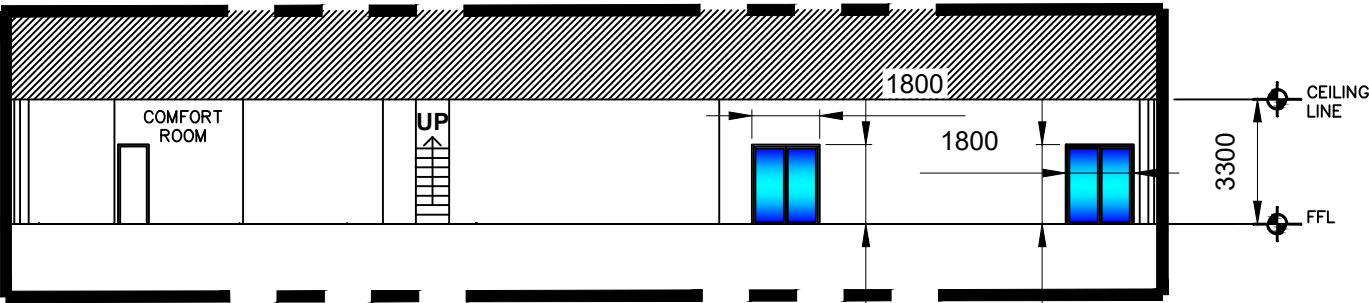
TRANSIT SHED 1 LAYOUT BLOW UP PLAN  
SCALE 1:250

EXISTING WALL TO BE REPAINTED

1. PREPARE THE SURFACE FOR REPAINTING
2. APPLY TWO (2) COATS ACRYLIC WATER-BASED ODORLESS, LOW-VOC, LEAD FREE FOR NEW AND EXISTING INTERIOR PARTITION AND WALL PAINT (SEMI-GLOSS)
3. COLOR SUBJECT FOR PPA'S APPROVAL

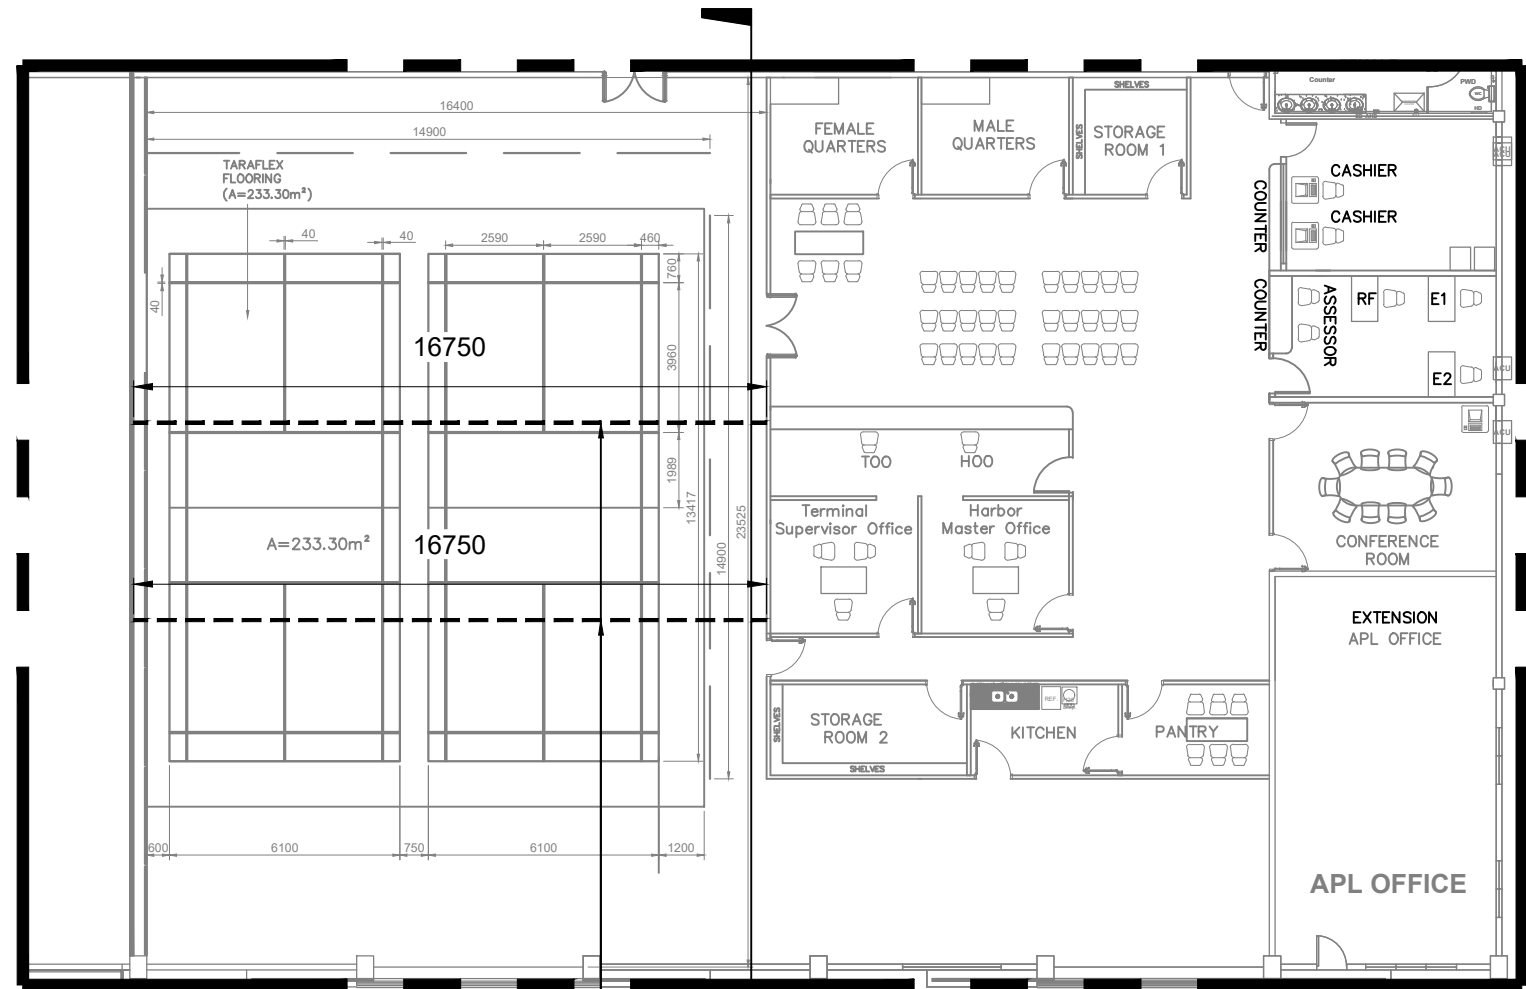
**BLOW UP PLAN**  
SCALE 1:200

HAIRLINE CRACKS ON THE FLOOR SLAB TO BE CLEANED, V-GROOVED, BE SEALED WITH STRUCTURAL EPOXY INJECTION, SANDED SMOOTH, PRIMED, AND REPAINTED.

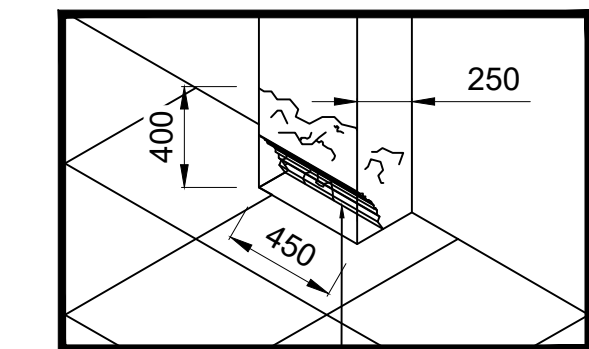
**DAMAGED COLUMN ISOMETRIC VIEW**  
NTS

DAMAGE COLUMN TO BE INJECTED WITH CONCRETE EPOXY INTO CRACKS, V-GROOVED, PATCH SURFACE, RESTORE COLUMN
