PHILIPPINE PORTS AUTHORITY PMO DAVAO

PROJECT TITLE: REPAIR OF SASA PORT PERIMETER FENCE INCLUDING PROVISION OF RAZOR WIRES FOR ADDITIONAL SECURITY MEASURES

LOCATION: KM. 10, SASA PORT AREA, DAVAO CITY

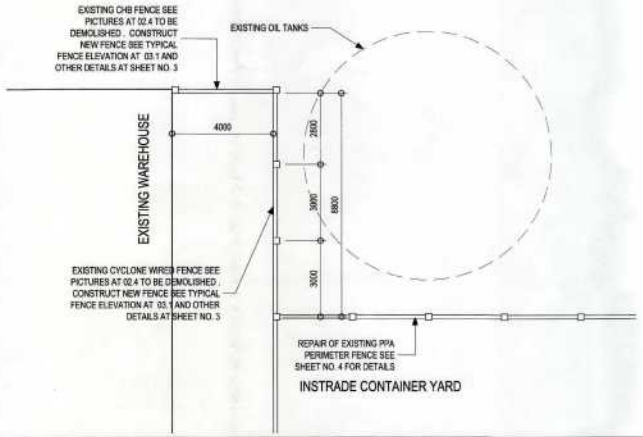
02.3 EXISTING PERIMETER FENCE–ACTUAL PICTURES
SCALE 1: NTS METERS

EXISTING PERIMETER FENCE TO BE DEMOLISHED AT BERTH NO. 10

EXISTING CYCLONE WIRED FENCE WITH CONCRETE COLUMN.

EXISTING CYCLONE WIRED CHB FENCE.

EXISTING PERIMETER FENCE TO BE DEMOLISHED AT PACIFIC OIL TANKS

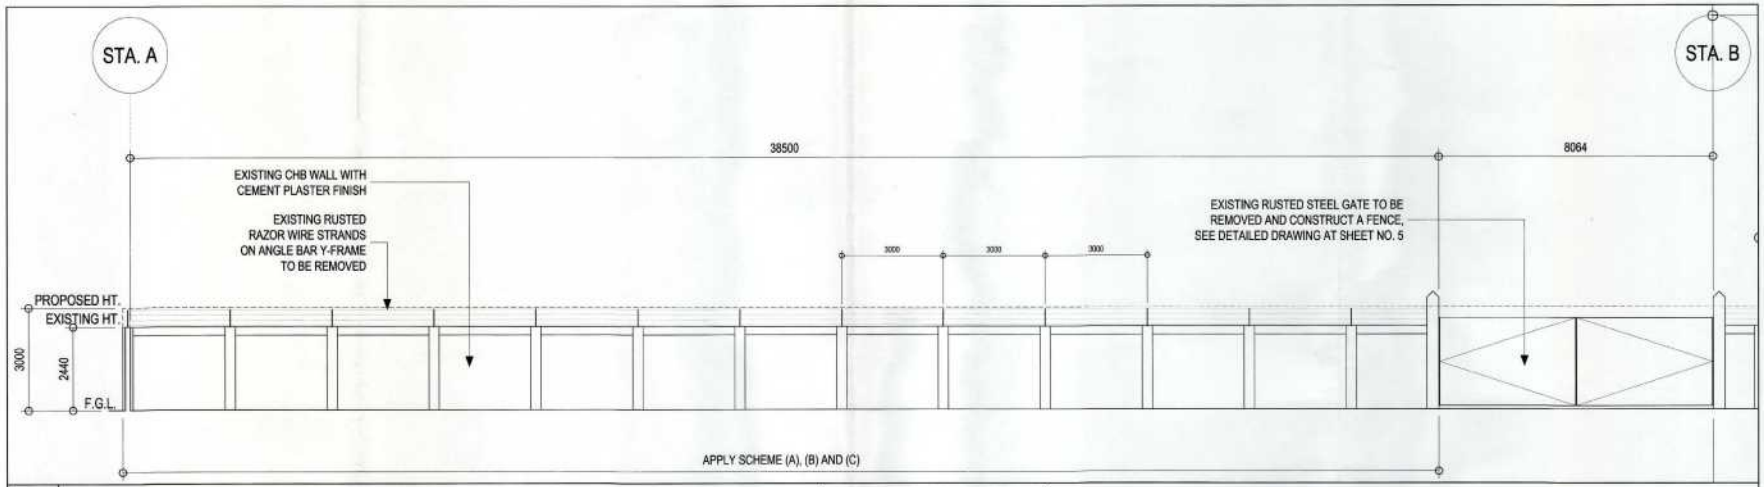
04.1 EXISTING PERIMETER FENCE FROM STA. A TO B = 46.56 METERS–ELEVATION (ADJACENT TO BERTH 9)
SCALE 1: 75 METERS

EXISTING RUSTED GATE AT SASA WHARF SIDE.

C - PERIMETER FENCE WITH CONCRETE COLUMNS AND BEAMS THAT HAVE EXPOSED REBARS SHALL BE REPLACE WITH NEW REBARS AND RE-CONCRETED; AND SHALL BE REPAINTED.

D - PERIMETER FENCE SHALL BE REPAINTED AND ALL EXISTING RUSTED BARB WIRE AND/OR RAZOR BLADE ASSEMBLY SHALL BE REPLACED WITH NEW.

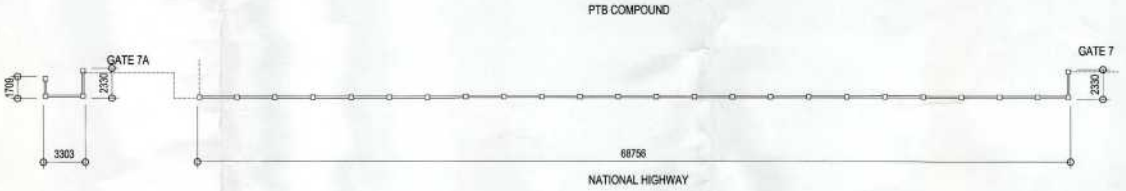
10.4 PERIMETER FENCE–ACTUAL PICTURE
SCALE 1: NTS METERS

EXISTING PERIMETER FENCE NEAR THE PM'S QUARTERS AT SASA WHARF SIDE.

NOTE:
- APPLY SCHEME (D)

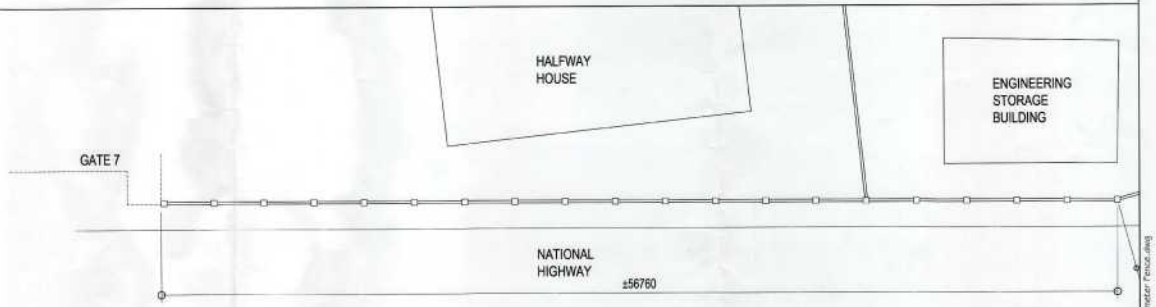
11.3 PERIMETER FENCE–ACTUAL PICTURES
SCALE 1: NTS METERS

EXISTING FENCE VIEWED INSIDE THE PTB COMPOUND.

EXISTING FENCE OF PTB COMPOUND VIEWED ALONG THE HIGHWAY.

A - PERIMETER FENCES WITH LESS THAN 3.00 METERS IN HEIGHT SHALL BE EXTENDED TO 3.00 METERS AND PROVIDE RAZOR BLADE ASSEMBLY AND BE PAINTED. SEE DETAILED DRAWING SHEET 16

B - PERIMETER FENCES WITH EXPOSED CHB SHALL BE PLASTERED, SCALED PLASTERING SHALL BE RE-PLASTERED AND SHALL BE REPAINTED.

C - PERIMETER FENCE WITH CONCRETE COLUMNS AND BEAMS THAT HAVE EXPOSED REBARS SHALL BE REPLACE WITH NEW REBARS AND RE-CONCRETED; AND SHALL BE REPAINTED.

D - PERIMETER FENCE SHALL BE REPAINTED AND ALL EXISTING RUSTED BARB WIRE AND/OR RAZOR BLADE ASSEMBLY SHALL BE REPLACED WITH NEW.
