| | EMERGENCY MAINTENANCE OF ELEVATED WATER TANK CAUSED BY 7.8 MAGNITUDE EARTHQUAKE ON JUNE 8, 2026 | <br>JOSE CARLITO Y. BRIONES JR.<br>DRAFTSMAN II (COS) | <br>RYAN L. BADAJOS<br>SENIOR ENGINEER A | <br>MARIA VIVIEN M. TANCO<br>PRINCIPAL ENGINEER A | <br>EDEL PETER L. DE LA ROSA<br>ACTING ESD MANAGER | <br>ATTY. CESAR M. DATAYA<br>PORT MANAGER | 1. LOCATION PLAN | 1/5 |
| | PORT OF GENERAL SANTOS, MAKAR WHARF,<br>GENERAL SANTOS CITY | | | | | | | |

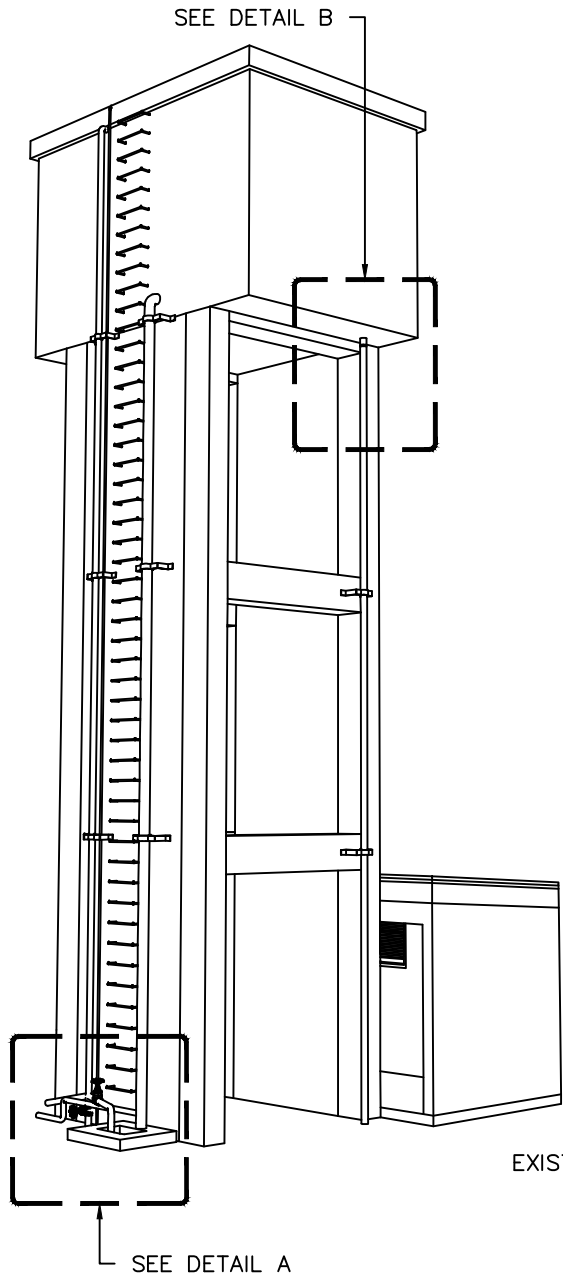
PERSPECTIVE  
NTS

EXISTING THREADED 3"Ø GATE VALVE TO BE REPLACED WITH 3"Ø GATE VALVES FLANGE TYPE WITH RUBBER SEAL (CAST IRON)

1. PROVIDE FLANGES TO MATCH EXISTING DIMENSIONS (THICKNESS, NUMBER OF BOLT AND HOLE DIMENSION) COMPATIBLE WITH THE SUPPLIED FLANGED GATE VALVE. ALSO PROVIDE AND INSTALL NEW FULL-FACE RUBBER GASKET AND BOLTS/NUTS.
2. PERFORM LEAK TEST.

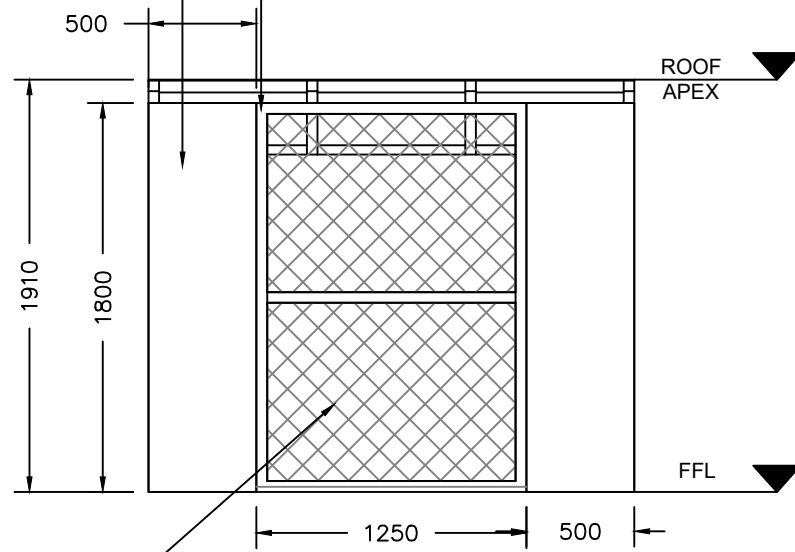
FRONT ELEVATION  
1:35

EXISTING STEEL DOOR WITH CYCLONE WIRE TO BE REPAINTED

WALL AREA TO BE REPAINTED

EXISTING 50mm X 50mm X 1.2mm SQUARE TUBE DOOR FRAME TO BE REPAINTED

ROOFING AND STEEL COMPONENT TO BE REPLACED WITH PRE-PAINTED GA. 26 RIB-TYPE G.I. ROOFING AND 50MM X 50MM X 1.2MM SQUARE TUBE
