| | EMERGENCY MAINTENANCE OF PPD OFFICE INCLUDING MAIN GATE STRUCTURE DUE TO 7.8 MAGNITUDE EARTHQUAKE ON JUNE 8, 2026 | <br>JOSE CARLITO Y. BRIONES JR.<br>DRAFTSMAN II (COS) | <br>CHARMAINE DJUNE L. MANTOYA<br>SUPERVISING ENGINEER A | <br>MARIA VIVIEN M. TANCO<br>PRINCIPAL ENGINEER A | <br>EDEL PETER L. DE LA ROSA<br>ACTING ESD MANAGER | <br>ATTY. CESAR M. DATAYA<br>PORT MANAGER | 1. LOCATION PLAN | 1/20 |
| | LOCATION<br>PORT OF GENERAL SANTOS, MAKAR WHARF,<br>GENERAL SANTOS CITY | | | | | | | |

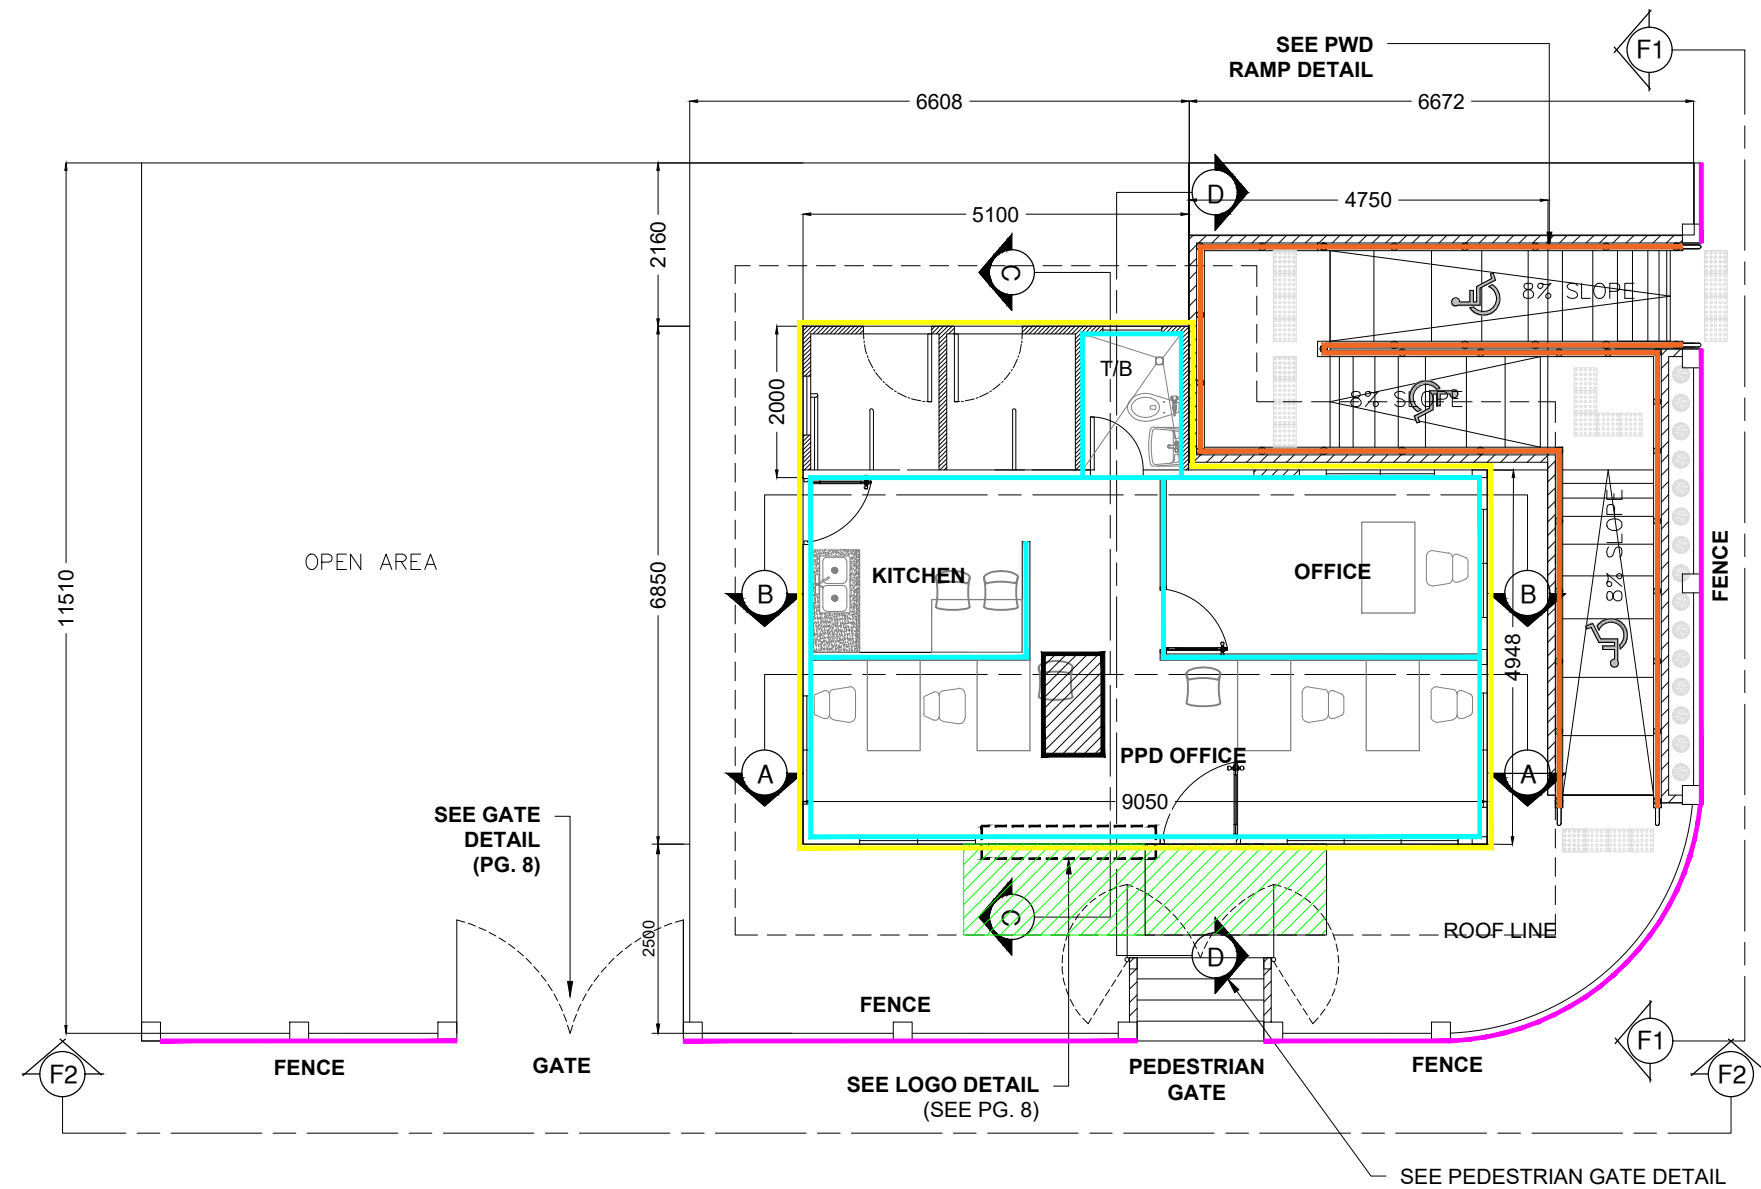
**FLOOR PLAN OF PPD BUILDING WITH FENCE**  
1:100

- INTERIOR WALL TO BE REPAINTED. (SEE PG. 3,4,5, ELEVATION DETAILS)
- EXTERIOR WALL TO BE REPAINTED. (SEE PG. 4,5, ELEVATION DETAILS)
- MAINTENANCE OF DAMAGED TILES. (SEE PG. 6, TILE LAYOUT)
- MAINTENANCE AND REPAINTING OF CONCRETE AND STEEL FENCE (SEE PG. 7, FENCE DETAIL)
- MAINTENANCE OF DAMAGED CEILING. (SEE PG. 8)
- CONCRETE CURB TO BE REPAINTED (SEE PG. 9, RAMP DETAIL)

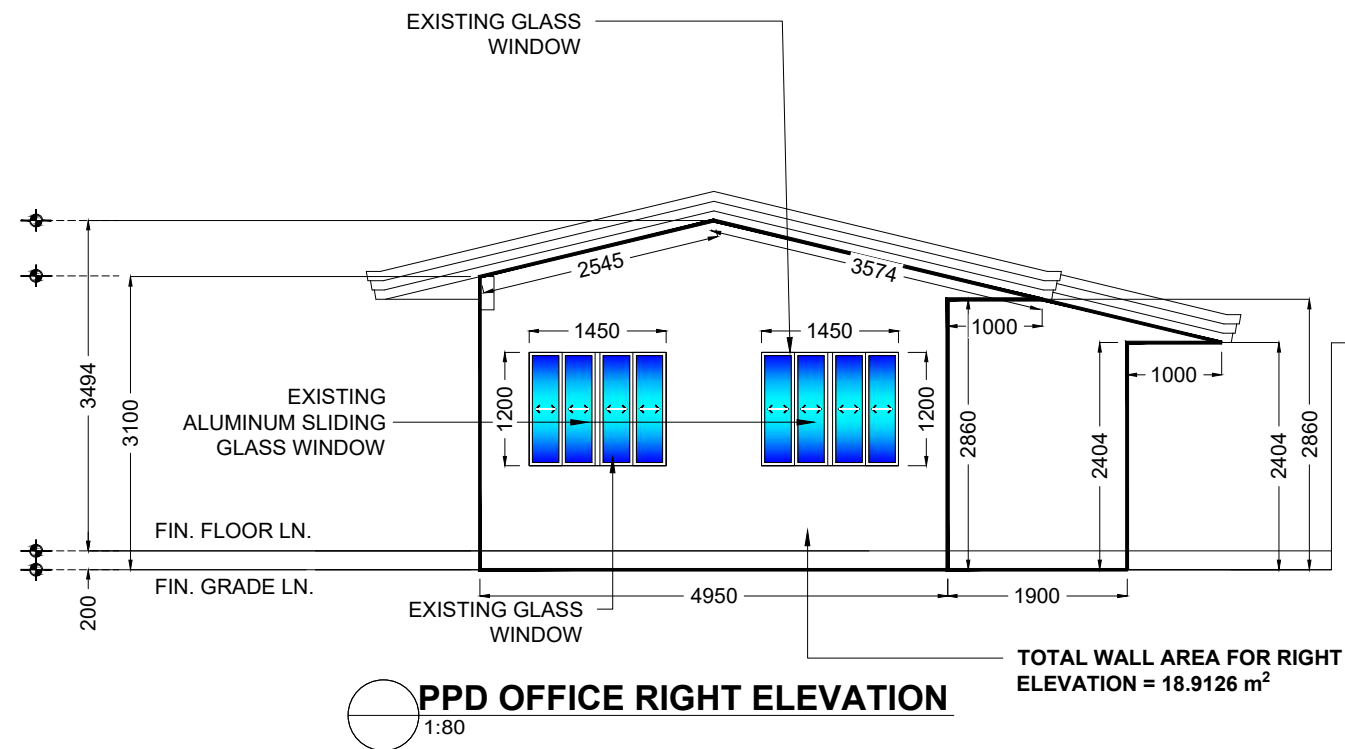
**TOTAL WALL AREA FOR RIGHT ELEVATION = 18.9126 m<sup>2</sup>**

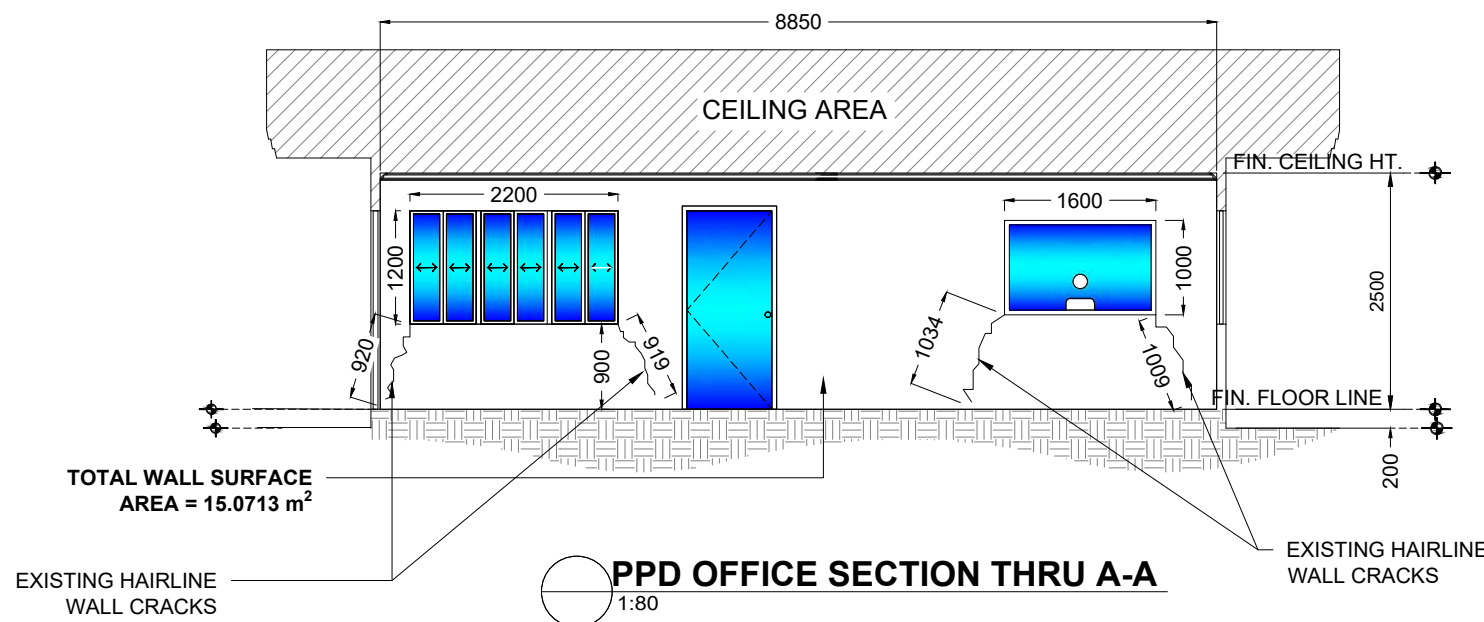
**TOTAL WALL SURFACE AREA = 15.0713 m<sup>2</sup>**

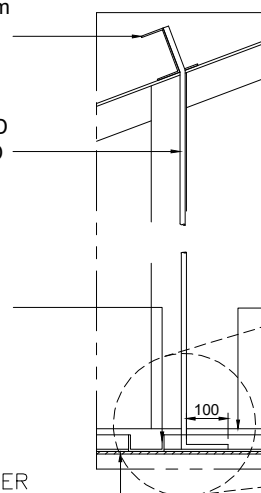
**CEILING HANGER DETAILS**  
NTS

50mm x 100mm  
x 2mm THK  
CEE PURLINS

10mmØ DEFROMED  
BARS FULLY WELD  
TO CEE PURLINS

19mm x 25mm x 0.40mm  
THK GI LIGHT METAL  
FURRINGS SPACED AT  
600mm O.C., BW

3.5mm THK. FIBER  
CEMENT BOARD

25 MM X 25 MM X 300 MM WIDE  
WOODEN AIR VENT SLOT  
(TO BE REPAINTED)

10mmØ DEFORMED  
BARS FULLY WELD  
TO MS ANGLE BAR

25mm X 25mm  
X 1/8" THK MS  
ANGLE BAR

19mm x 25mm  
x 0.40mm THK GI  
LIGHT METAL  
FURRINGS SPACED  
AT 600mm O.C., BW

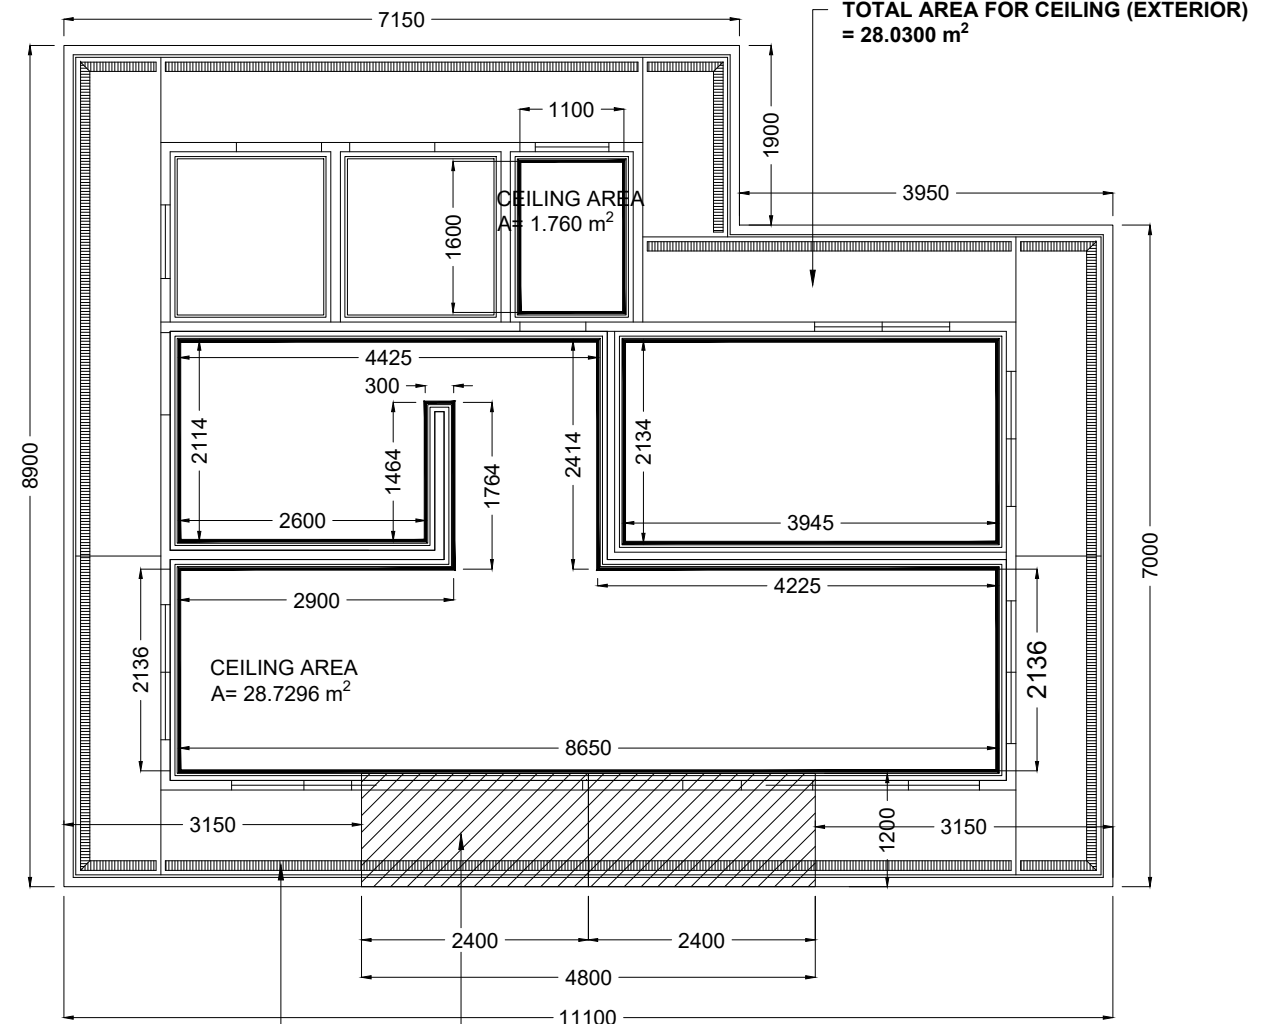
**PPD OFFICE CEILING LAYOUT**  
1:100

MAINTENANCE OF CEILING 3.5MM THK. FIBER CEMENT BOARD, 19MM X 25MM X 0.40MM THK GI LIGHT METAL FURRINGS SP@ 600MM O.C.B.W.  
(SEE CEILING HANGER DETAILS)

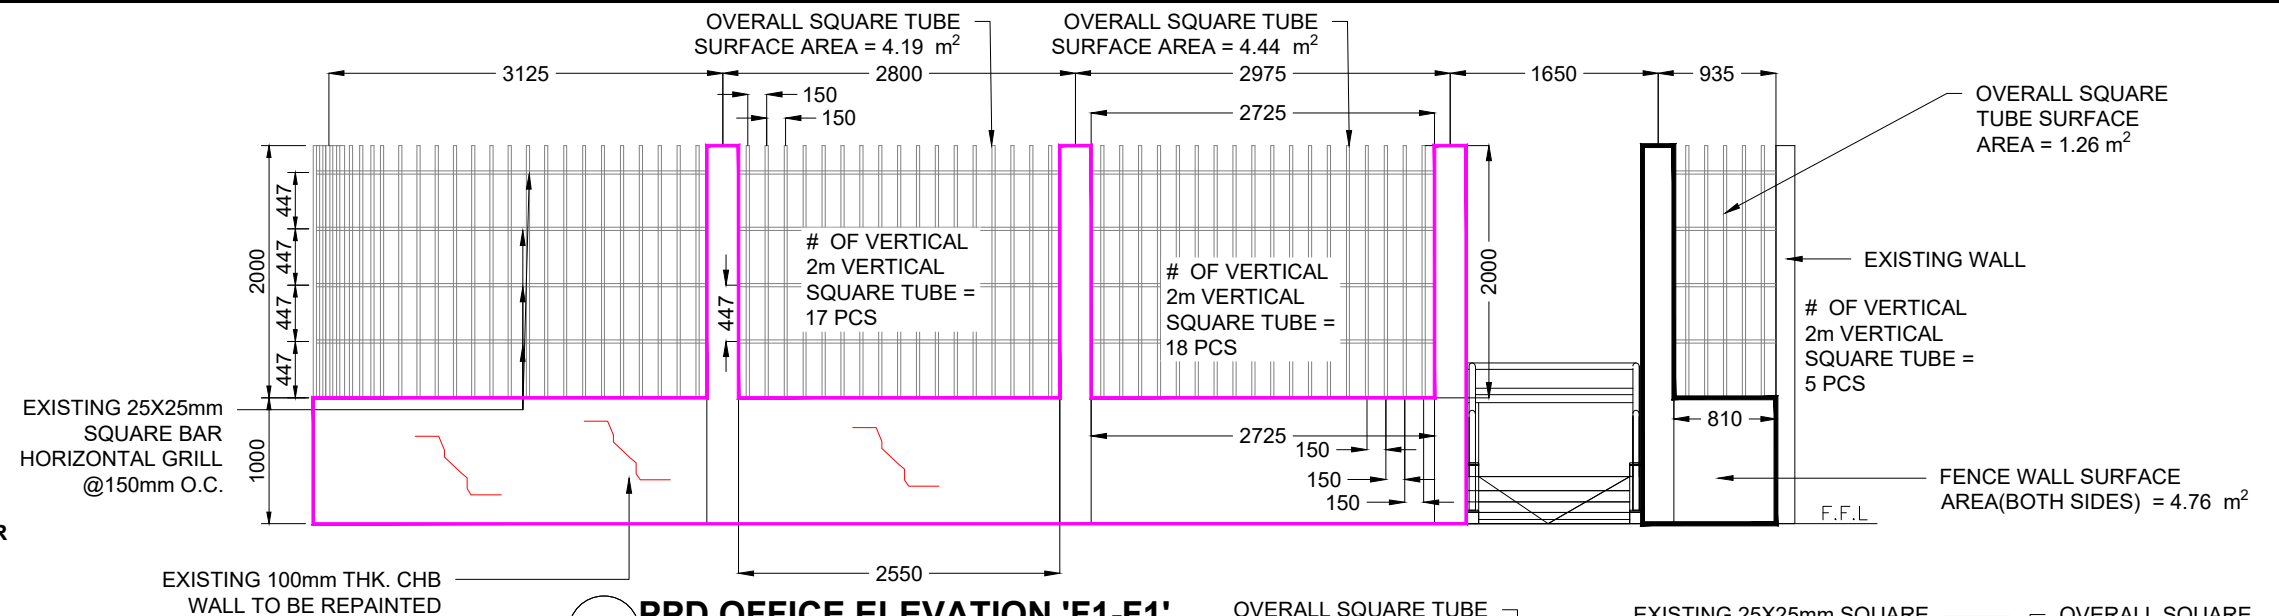
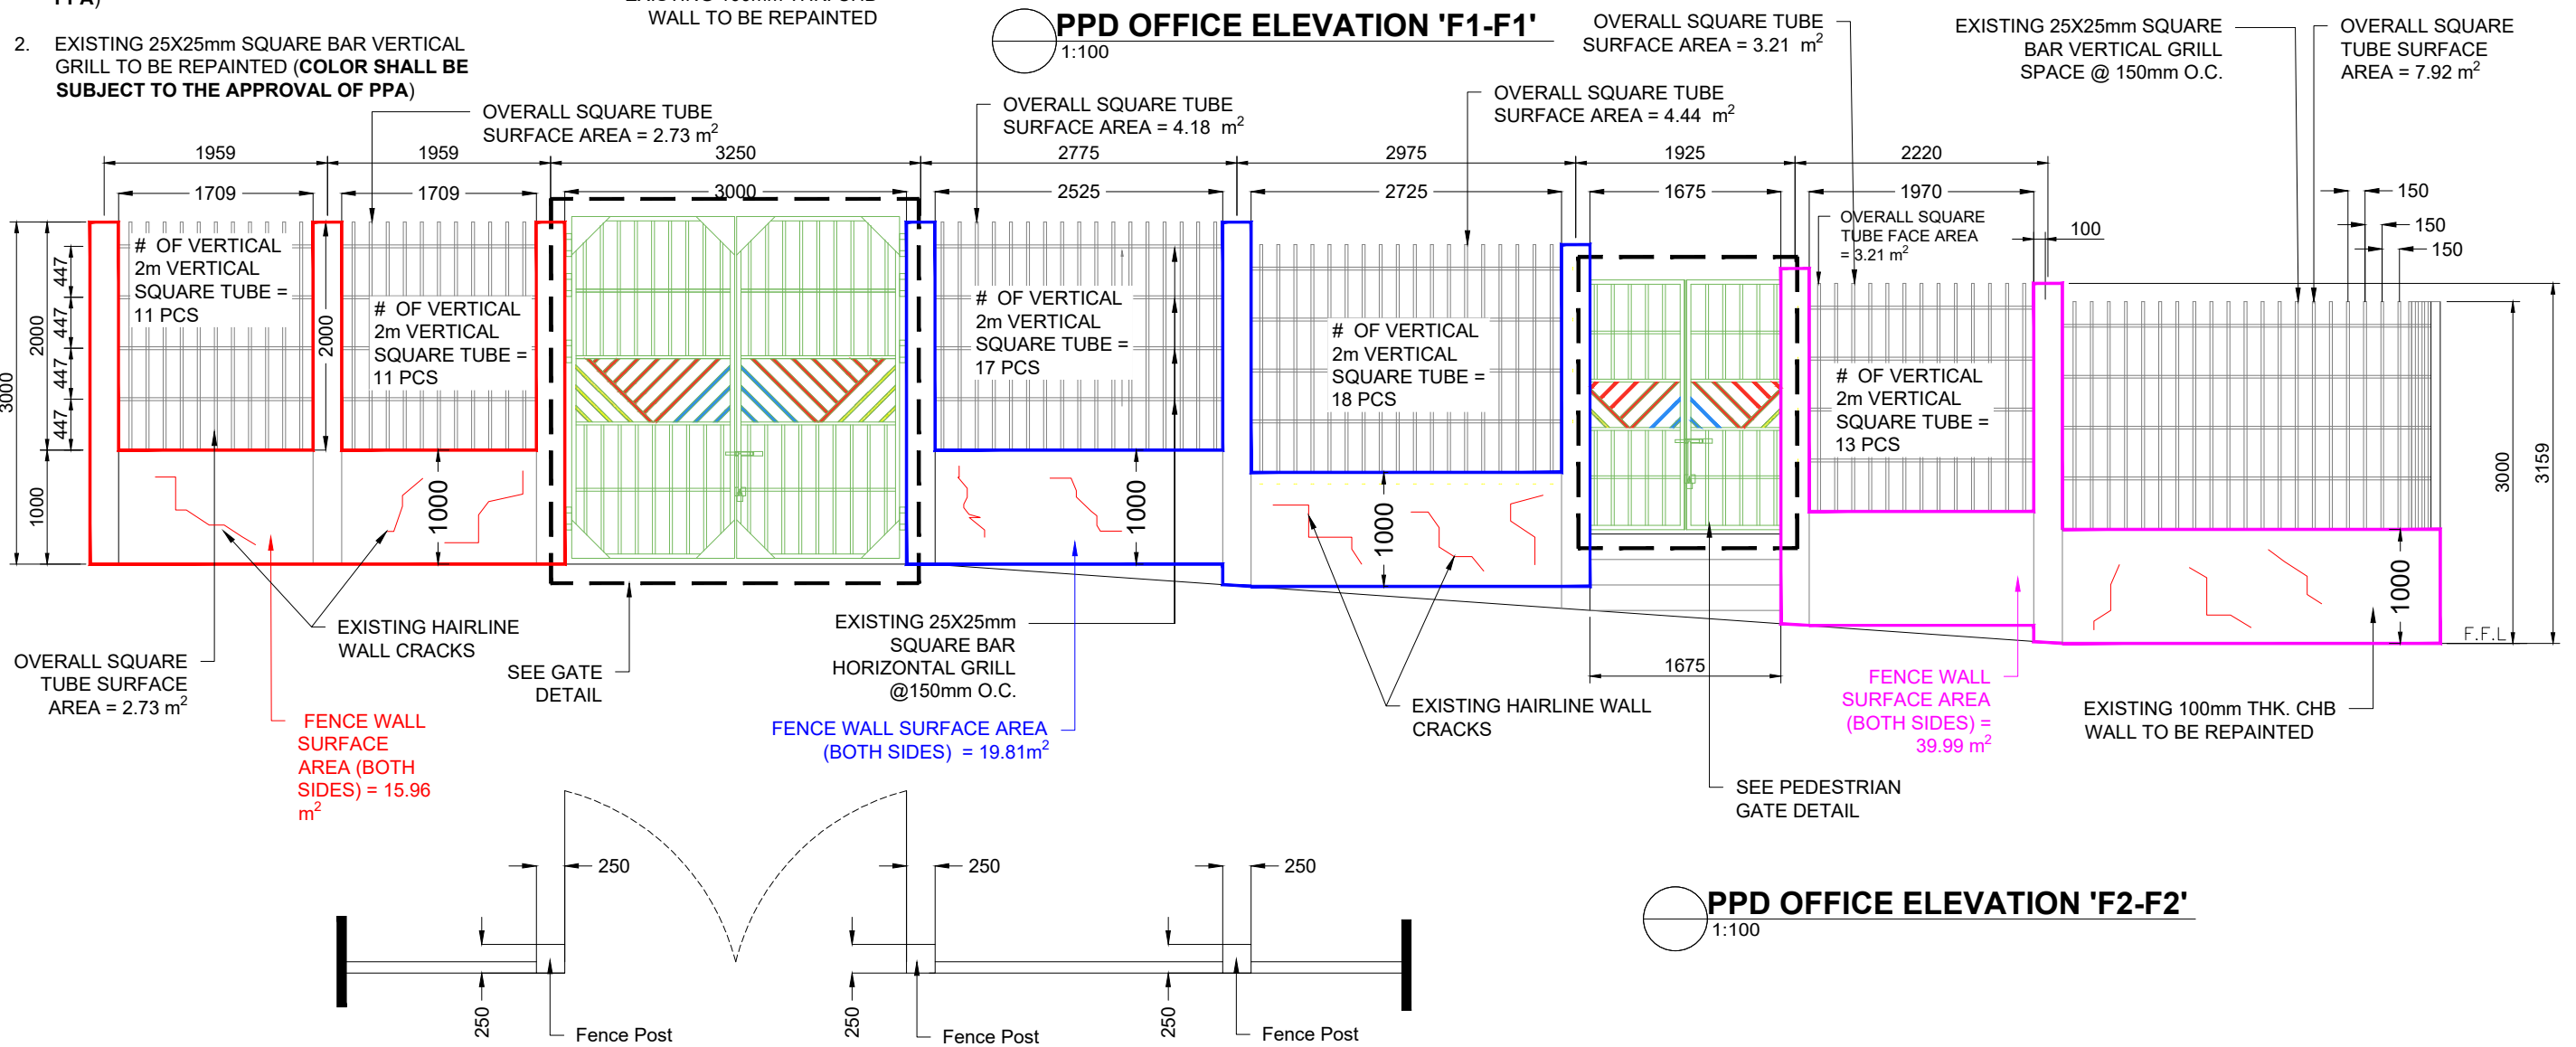
| SHEET CONTENT: | 1. PPD OFFICE ELEVATION F1-F1<br>2. PPD OFFICE ELEVATION F2-F2 |

1. THOROUGHLY CLEAN ALL SURFACES TO REMOVE DIRT, DUST, GREASE, RUST, AND OTHER CONTAMINANTS. PREPARE SURFACES AS REQUIRED PRIOR TO APPLICATION OF NEW PAINT.
2. APPLY RUST CONVERTER AND MARINE EPOXY PRIMER ON ALL STEEL AREAS WITH EXPOSED SURFACE
3. EXISTING HAIRLINE WALL CRACKS TO BE CLEANED, V-CUT (10mm DEPTH, 10mm WIDTH) , INJECTED WITH STRUCTURAL CONCRETE EPOXY, SANDED SMOOTH, PRIMED, AND REPAINTED.
4. WALL FENCE TO BE REPAINTED WITH TWO (2) COATS ELASTOMERIC ODORLESS ANTIBACTERIAL GLOSS LATEX PAINT (COLOR SHALL BE SUBJECT TO THE APPROVAL OF PPA)
2. EXISTING 25X25mm SQUARE BAR VERTICAL GRILL TO BE REPAINTED (COLOR SHALL BE SUBJECT TO THE APPROVAL OF PPA)

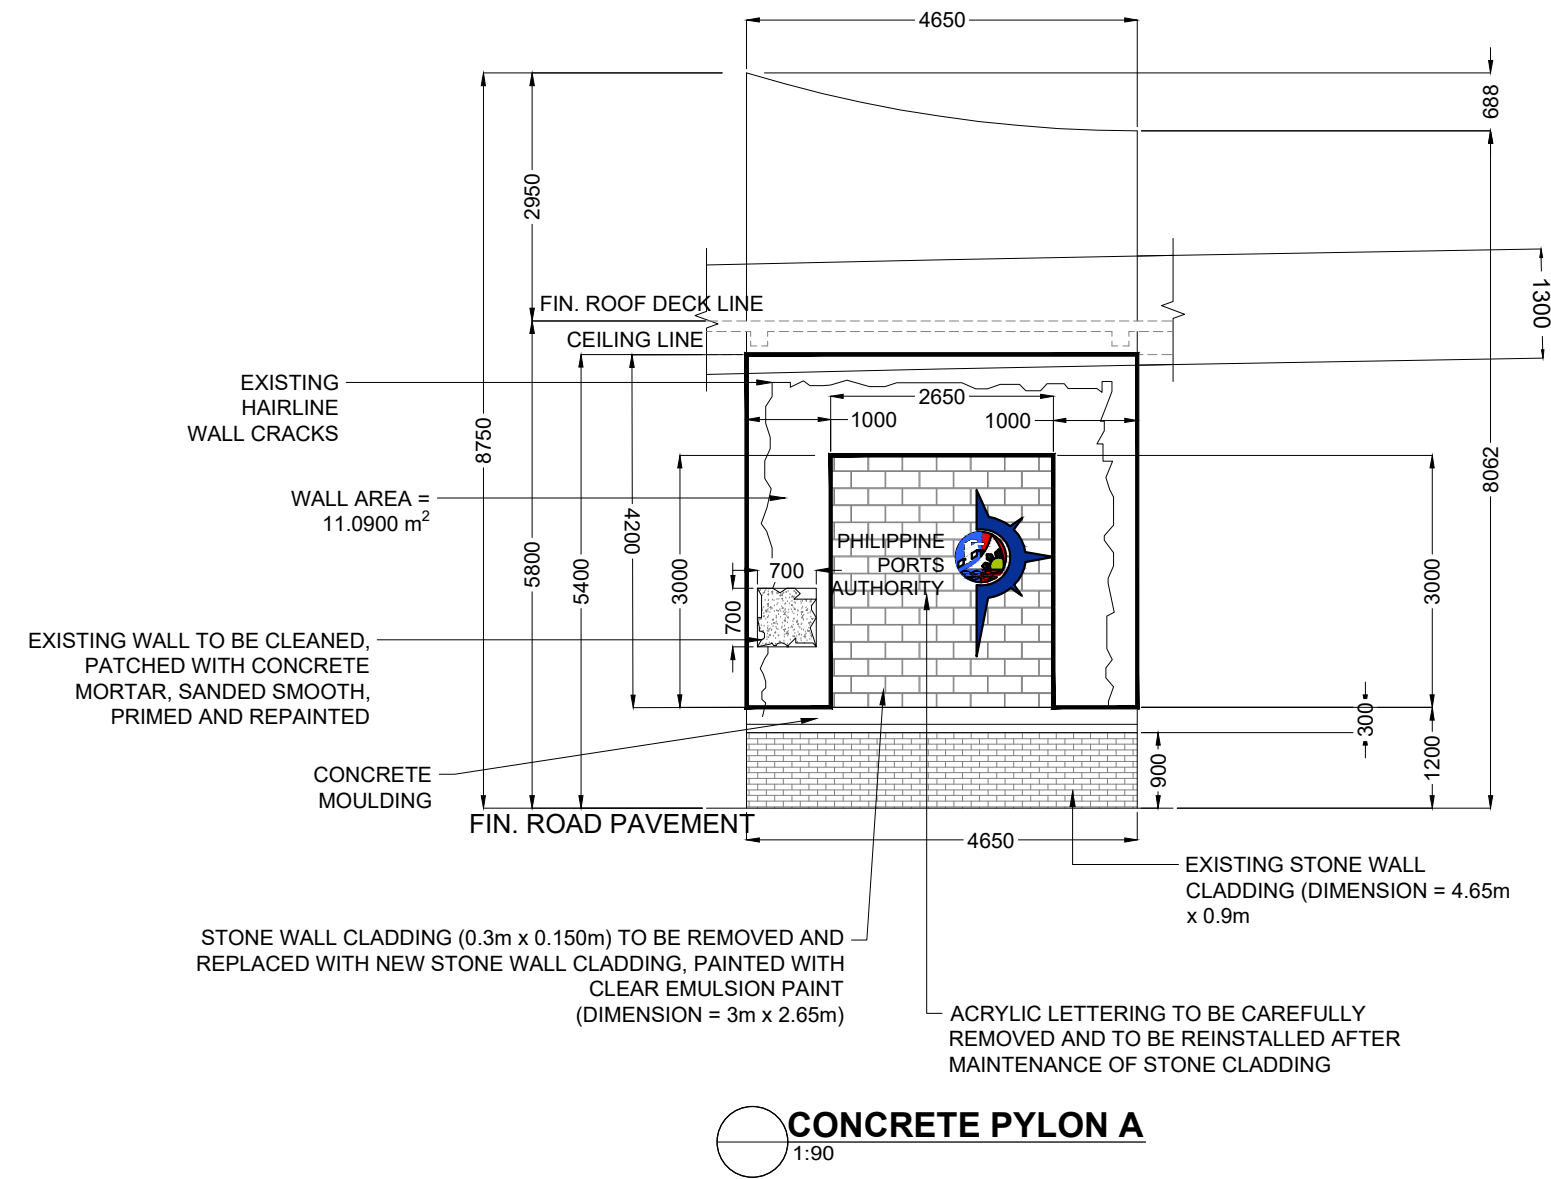
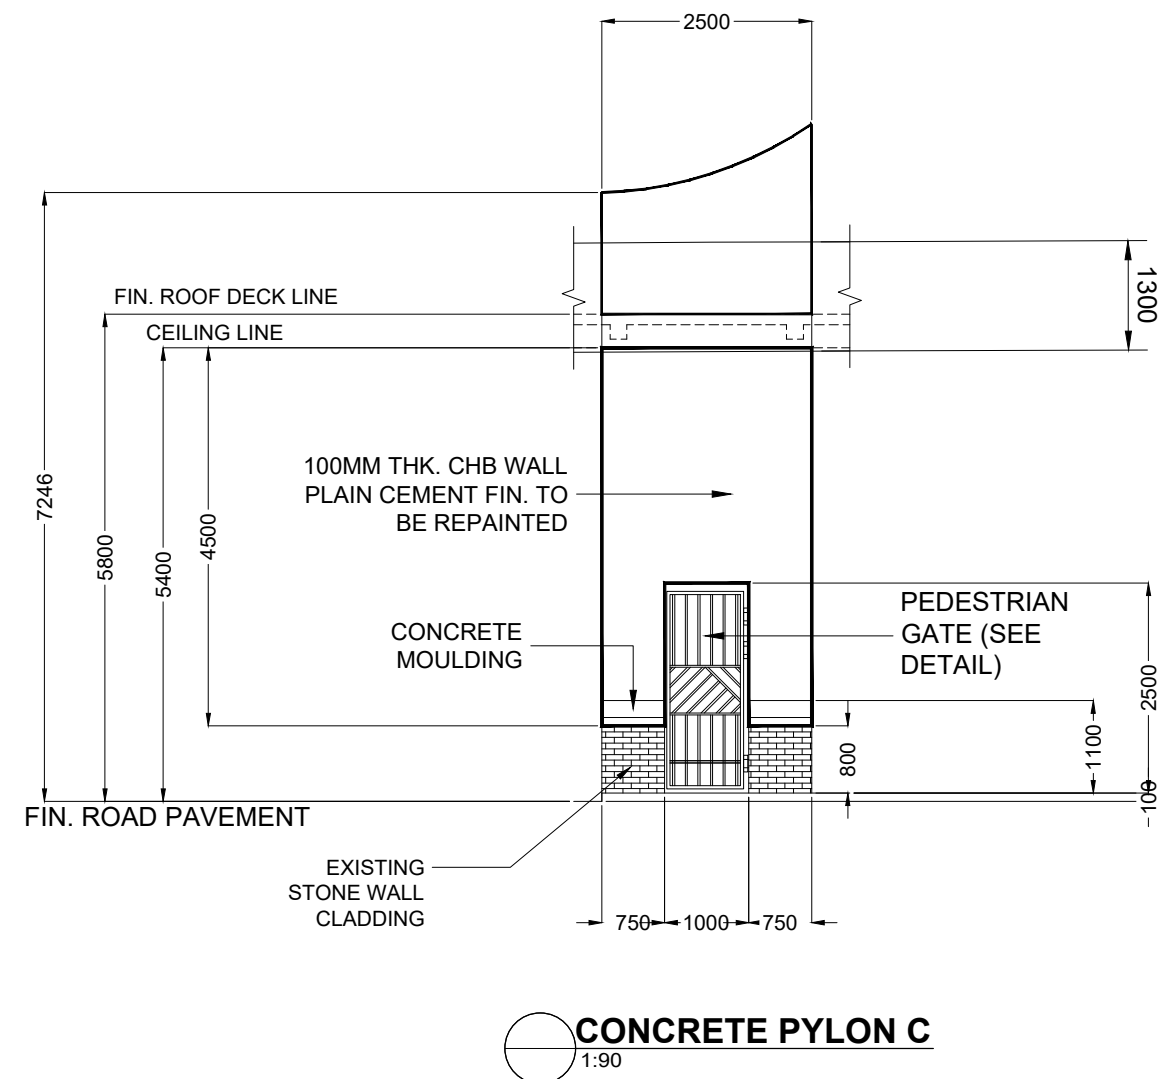
1. THOROUGHLY CLEAN ALL SURFACES TO REMOVE DIRT, DUST, GREASE, RUST, AND OTHER CONTAMINANTS. PREPARE SURFACES AS REQUIRED PRIOR TO APPLICATION OF NEW PAINT.
2. EXISTING HAIRLINE WALL CRACKS TO BE CLEANED, V-CUT (10mm DEPTH, 10mm WIDTH), INJECTED WITH STRUCTURAL CONCRETE EPOXY, SANDED SMOOTH, PRIMED, AND REPAINTED.
3. STONE WALL CLADDING TO BE REPAINTED WITH CLEAR EMULSION PAINT

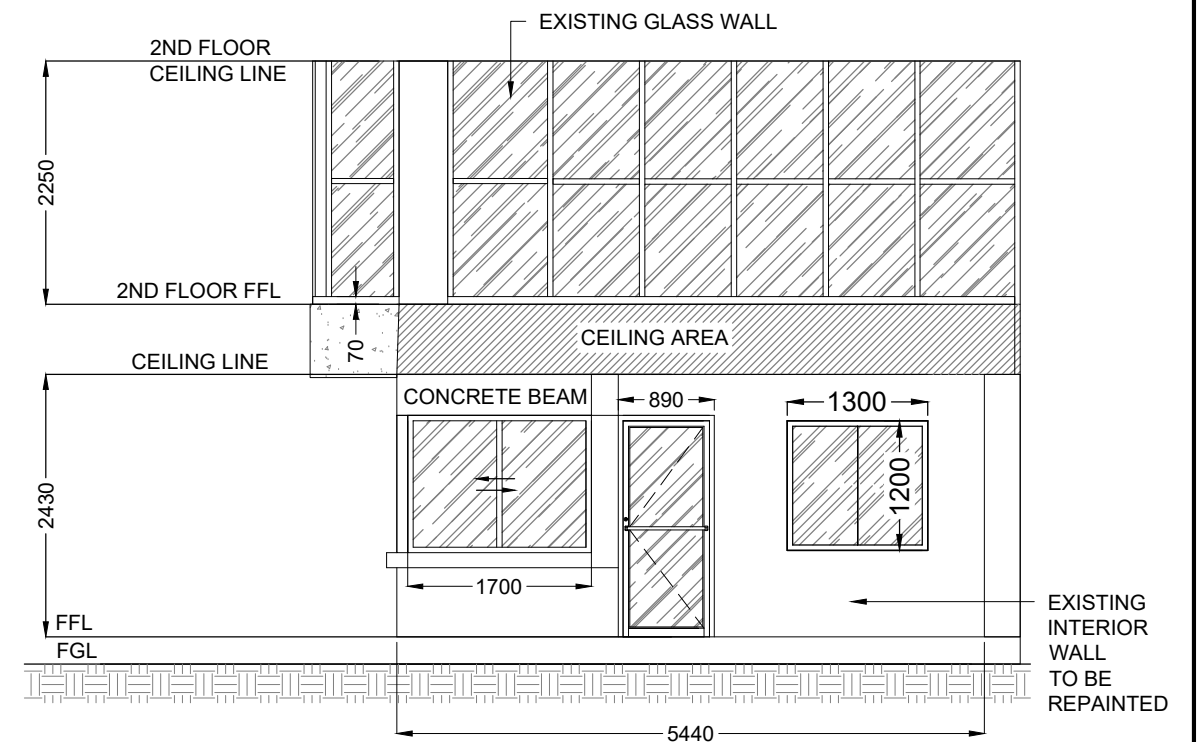
**GUARD HOUSE/COMMAND CENTER SECTION C**  
SCALE 1:70

1. THOROUGHLY CLEAN ALL SURFACES TO REMOVE DIRT, DUST, GREASE, RUST, AND OTHER CONTAMINANTS. PREPARE SURFACES AS REQUIRED PRIOR TO APPLICATION OF NEW PAINT.
2. INTERIOR WALL TO BE REPAINTED WITH TWO (2) COATS BIOFRESH ACRYLIC ODORLESS ANTIBACTERIAL GLOSS LATEX PAINT INCLUDING SURFACE PREPARATION (**COLOR SHALL BE SUBJECT TO THE APPROVAL OF PPA**)
3. EXISTING HAIRLINE WALL CRACKS TO BE CLEANED, V-CUT (10mm DEPTH, 10mm WIDTH), INJECTED WITH STRUCTURAL CONCRETE EPOXY, SANDED SMOOTH, PRIMED, AND REPAINTED.
