| <p>PHILIPPINE PORTS AUTHORITY</p> | <p>PROJECT TITLE</p> <p>REPAIR AND IMPROVEMENT OF PORT PHYSICAL FACILITIES PROJECT 2022 (PHASE 2) TO REPAIRING WORKS ON CYCLONE FENCE NEAR CY III AND OUTSIDE NORTH GATE AREA INCLUDING VARIOUS MANHOLE COVERS AND LATERAL DRAIN COVERS</p> <p>LOCATION</p> <p>PORT OF GENERAL SANTOS, MAKAR WHARF, GENERAL SANTOS CITY</p> | <p>PREPARED BY</p> <p>JOE CARLOS SORIANO<br/>SUPERVISOR</p> | <p>CHECKED BY</p> <p>CHARMAINE DUKE J. MANTOYA<br/>SUPERVISOR</p> | <p>REVIEWED BY</p> <p>MARIA VIVIAN M. PANCO<br/>PRINCIPAL ENGINEER</p> | <p>RECOMMENDED APPROVAL</p> <p>JAMESON LEE<br/>EDD MANAGER</p> | <p>APPROVED BY</p> <p>ATTY. CESAR M. AYALA<br/>PORT MANAGER</p> | <p>SHEET CONTENT</p> <p>1. LOCATION PLAN</p> | <p>DATE:</p> <p>1/3</p> |

| | <b>PROJECT TITLE</b><br>BOOTHING MAINTENANCE OF PORT PHYSICAL FACILITIES PROJECT 2025 (PACKAGE 2 - 10 REPAIRS/REPLACEMENTS ON CYCLONE RESISTANT FENCE CYRS IN A AND OUTSIDE NORTH GATE AREA INCLUDING X-RAY LAMIN AND DAMAGED WIRE, 10 REPAIRS AND REPLACEMENT OF DAMAGED STEEL JOINTS AND LAMIN AND DAMAGED WIRE, 10 REPAIRS AND REPLACEMENT OF DAMAGED STEEL JOINTS AND LAMIN AND DAMAGED WIRE. | <b>PROJECTIVITY</b><br>JOSEPH P. TORRANO<br>

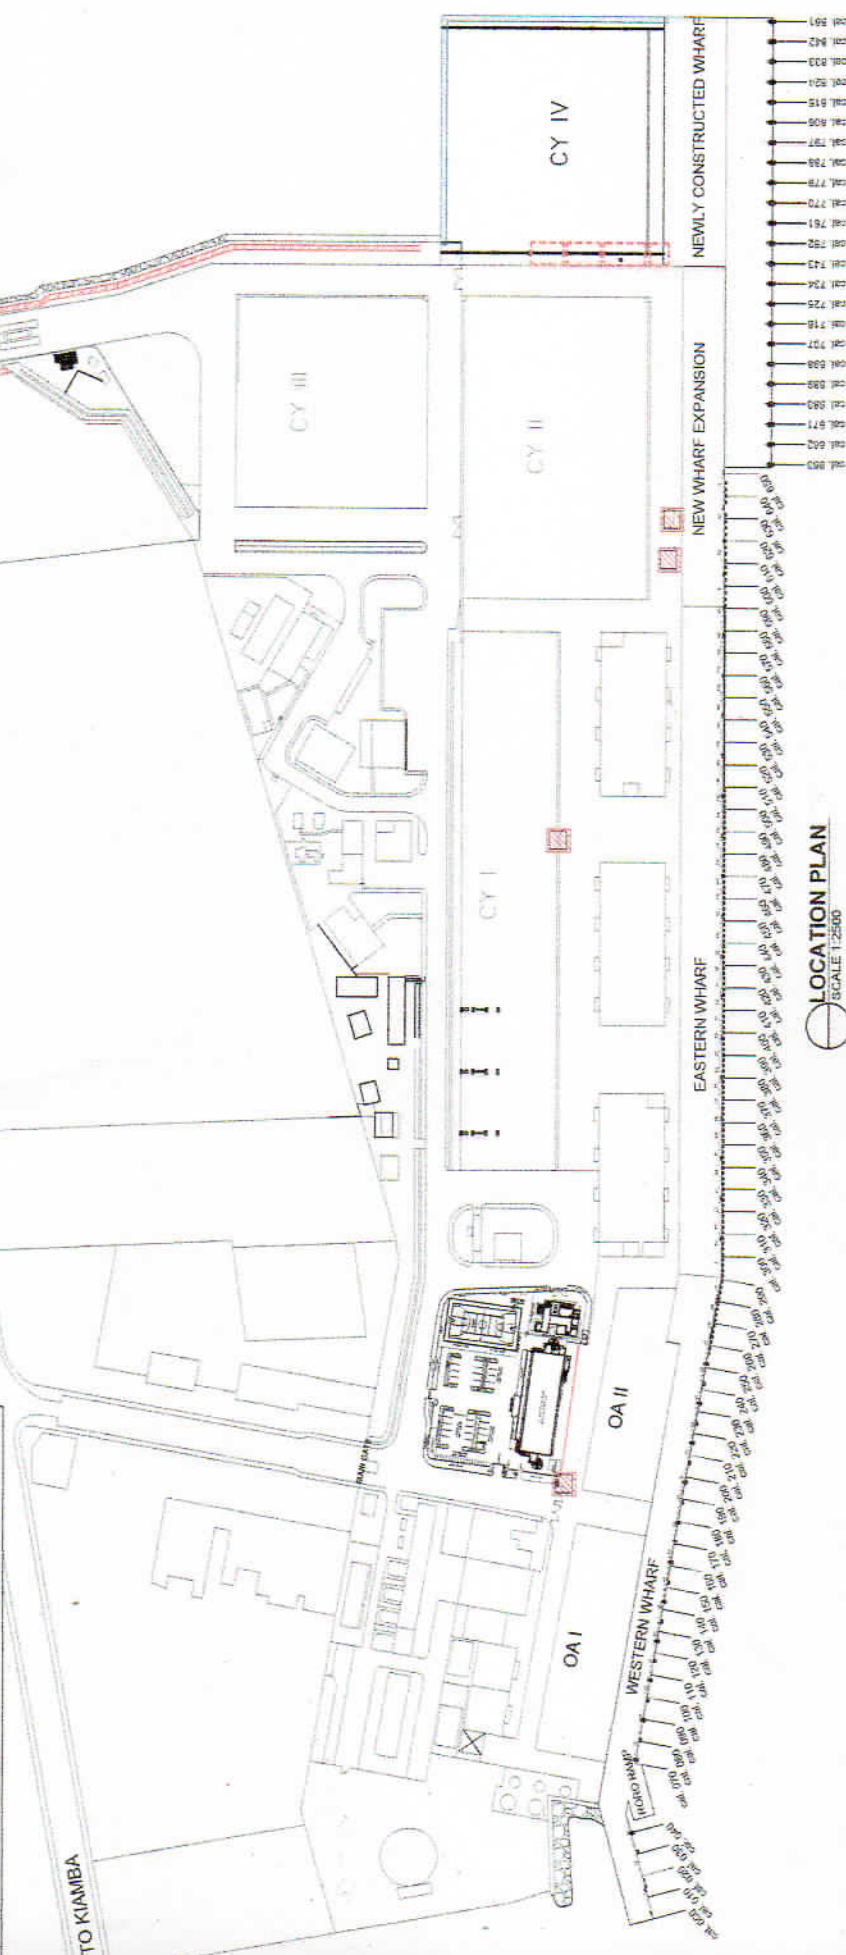
- REPAINTING OF CYCLONE FENCE NEAR CY III AND OUTSIDE NORTH GATE(SEE DETAILED DRAWING, LM=280.00m)
- REPAINTING OF CYCLONE FENCE NEAR CY IV(SEE DETAILED DRAWING, LM=201.00m)
- REPAIR OF DAMAGED MANHOLE COVERS(SEE DETAILED DRAWING)
- REPAIR OF DAMAGED LATERAL DRAIN COVERS(SEE DETAILED DRAWING)

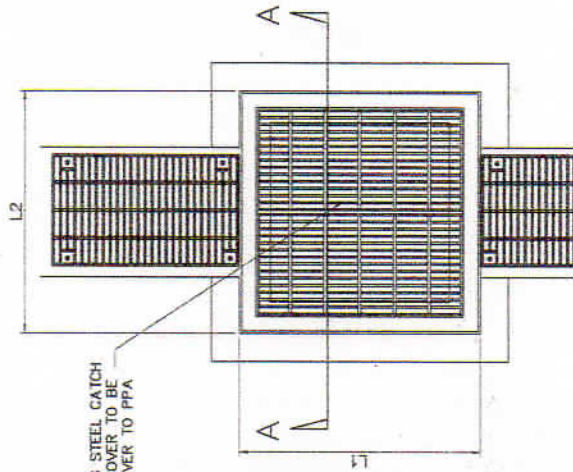
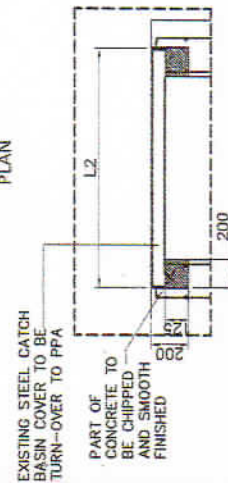
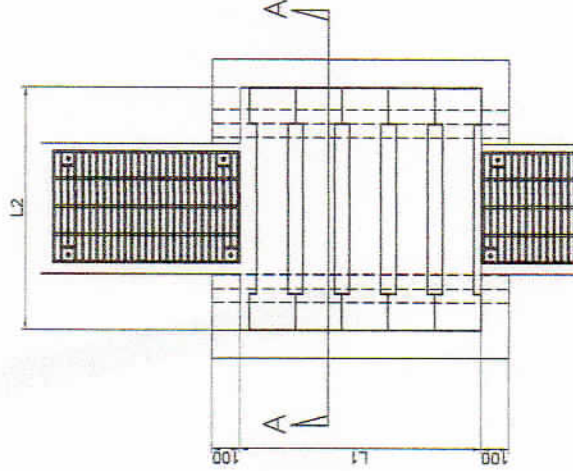
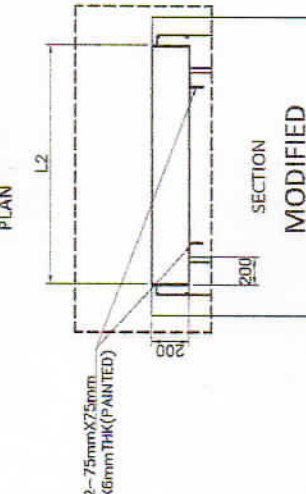
# CATCH BASIN COVER DETAIL

SCALE 1:30

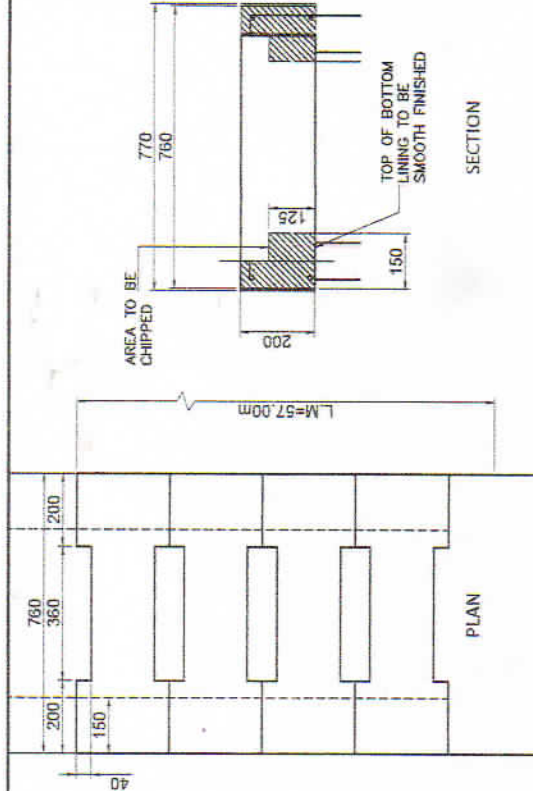
# LATERAL DRAIN COVER DETAIL

SCALE 1:15

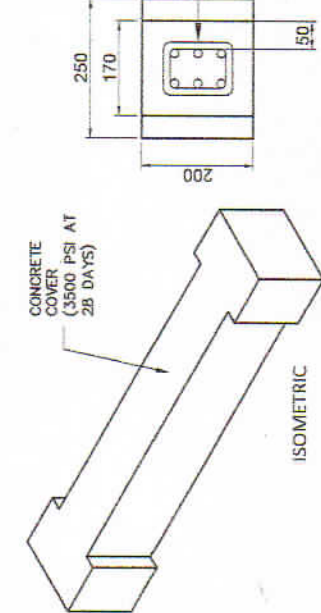
# CATCH BASIN AND LATERAL DRAIN DETAIL

SCALE 1:10
